June 1945 as  
Advance Restricted Report L5F01a

EFFECT OF FABRIC DEFLECTION AT HIGH SPEEDS ON THE  
AERODYNAMIC CHARACTERISTICS OF THE HORIZONTAL  
TAIL SURFACE OF AN SB2D-1 AIRPLANE

By Carl F. Schueller and Peter F. Korycinski

Langley Memorial Aeronautical Laboratory  
Langley Field, Va.

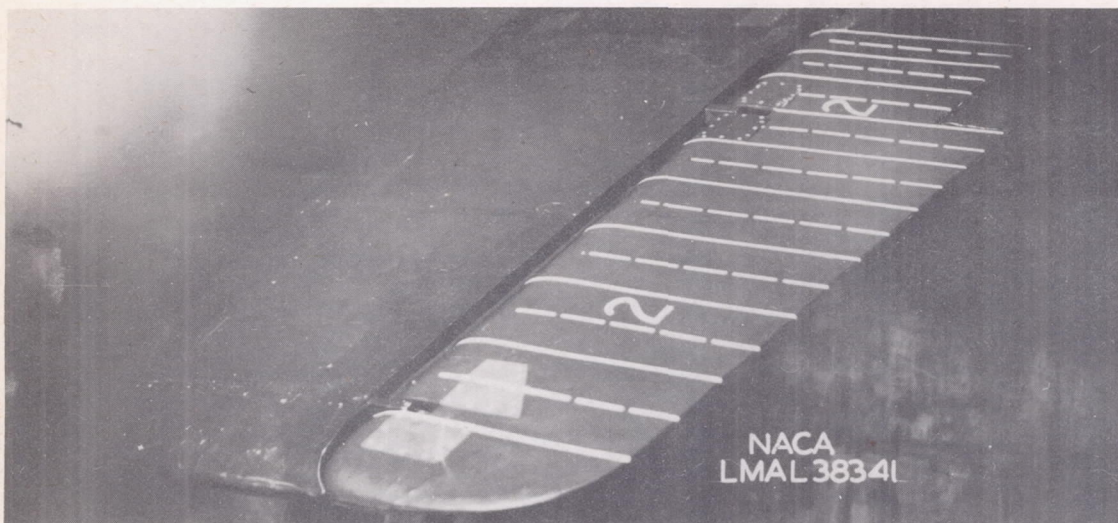
(a) Upper surface.

(b) Lower surface.

Figure 6.- Static condition for elevator 2.

deflection. (See fig. 1.) Solid stripes were painted over each rib and broken stripes midway between the ribs, on the upper and lower surfaces. These stripes are straight and parallel for the static condition (see fig. 6) but because of air loads the fabric deflects and the stripes bend. Cameras in fixed positions were provided to photograph the elevator surfaces simultaneously and thus provide records of the fabric deflection. The deflection of the painted stripes was measured from enlargements of the photographs.

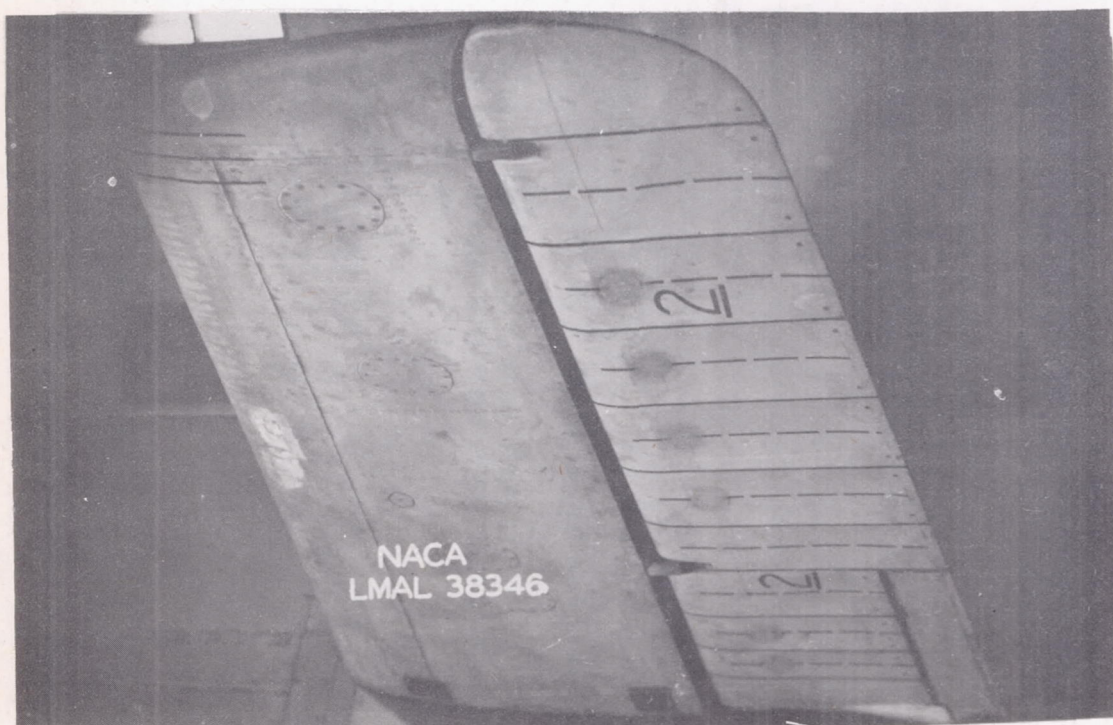
(b) Lower surface.

Figure 9.- Fabric deflection of elevator 2 (8-inch rib spacing).  
 $M = 0.55$ ;  $\alpha = 0^\circ$ ;  $\delta = 3.3^\circ$ ; elevator seal removed; elevator  
vents at trailing edge.

Elevator 2.- Figure 9 is a photograph of the fabric deflection of both surfaces of elevator 2 (8-inch rib spacing) at  $\alpha = 0^\circ$ ,  $\delta = 3.3^\circ$ , and  $M = 0.55$ . Considerable bulge occurred on the top surface behind the hinge line. This bulge changed to depression on the rear part of the elevator. Since the fabric was sewed to the elevator ribs, the solid stripes should show no deflection. A number of solid stripes, however, are deflected. (See fig. 9(a).) Deflection of the solid stripes indicates failure of the fabric attachment at these points and is the beginning of a condition that would result in complete failure of the surface if the air loads were increased. Figure 10 is a photograph of the fabric deflection at  $\alpha = 3^\circ$ ,  $\delta = -0.7^\circ$ , and  $M = 0.62$ . In general, the upper surface is slightly bulged just behind the hinge line. The most serious bulge occurs at the inboard hinge and is believed to be a result of weak fabric attachment around the hinge-pocket cut-out rather than of local-suction peak pressures. Figure 10 also shows the fabric pulled away from the ribs. (Note solid stripes.)

Figure 20 is a photograph of the fabric deflection with vents at the elevator leading edge for  $\alpha = 0^\circ$ ,  $\delta = 4^\circ$ , and  $M = 0.55$ . Comparison of figures 20 and 9 shows that the upper-surface bulge is changed to depression with vents at the elevator leading edge, except for a small local bulge at the upper surface near the inboard hinge. It is apparent from figures 19 and 20 that location of the vents at the elevator leading edge will eliminate the danger of the fabric pulling loose from the ribs and failing for elevator angles up to at least  $4^\circ$ .

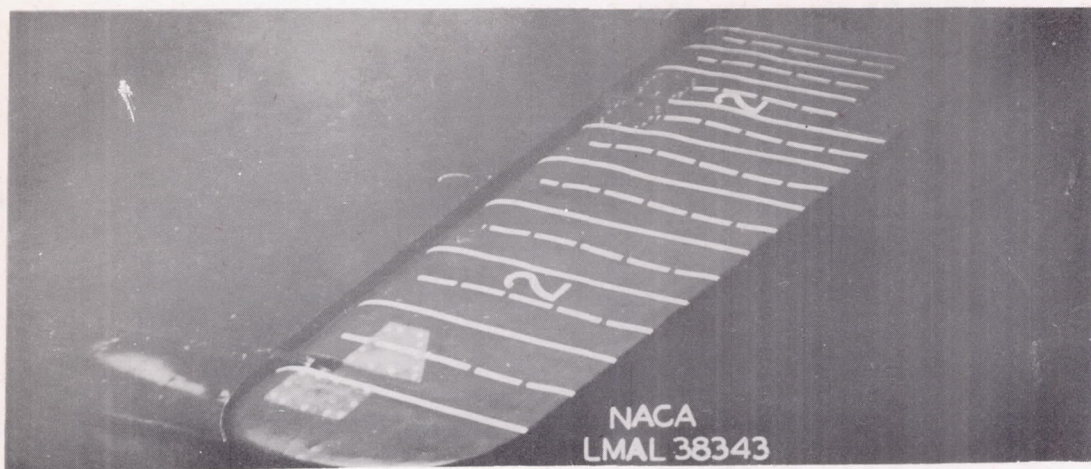
(a) Upper surface.

Figure 10.- Fabric deflection of elevator 2.  $M = 0.62$ ;  
 $\alpha = 3^\circ$ ;  $\delta = -0.7^\circ$ ; elevator vents at trailing edge.
